Ribline™

Case Study

Ribline Trenchless, Structural Pipe Rehabilitation- Manteca, California Project

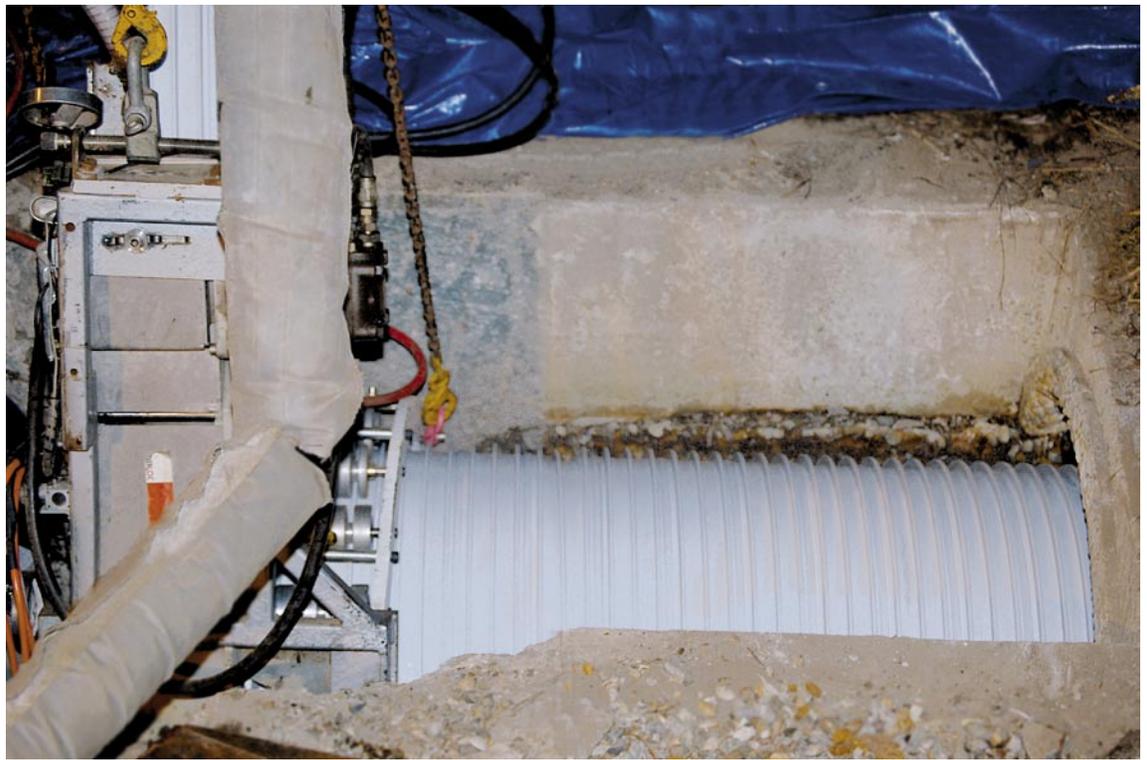
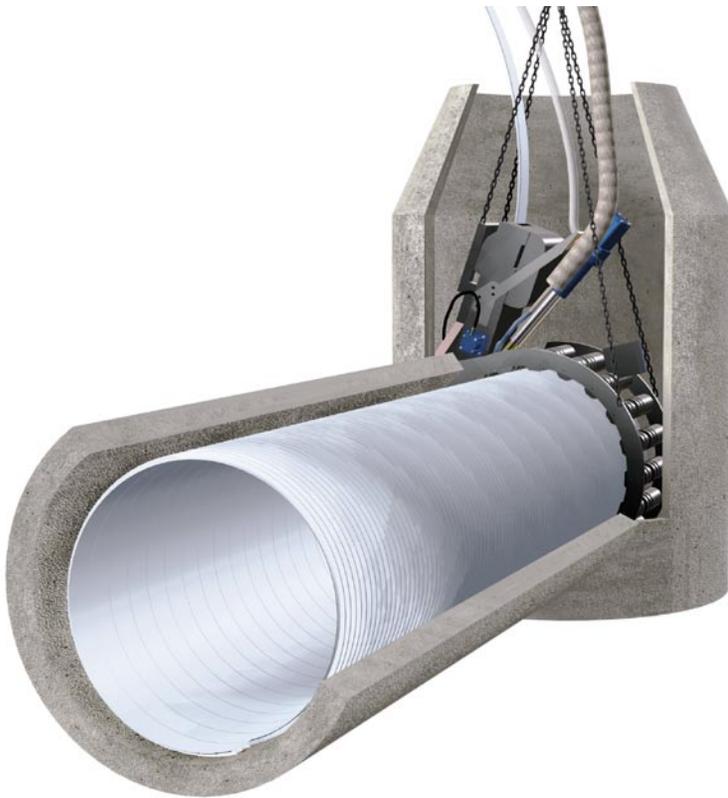
easily and provides excellent structural support. The pipe is made of imbedded steel reinforced high-density polyethylene (HDPE). Its smooth interior surface resists the chemical corrosion usually found in sewers and the completed encased steel ribs give the pipe superior structural strength.

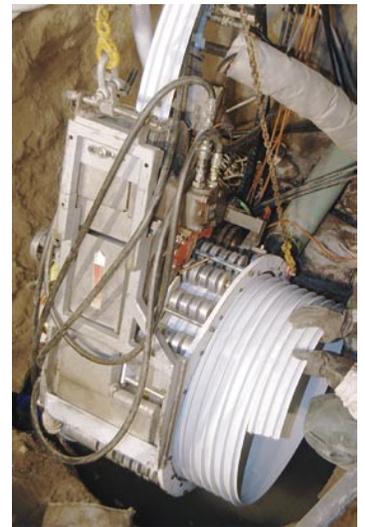
The installation repaired more than 300 linear feet of pipe in less than two days. Ribline arrives at the jobsite on a reel. The installation equipment is positioned at the access point and spirally winds out the pre-manufactured profile at a diameter small enough to pass through the host pipe. The wraps of profile are extrusion welded together to produce a continuous jointless HDPE liner with high stiffness.
